Some issues and concern from 2013 rockslide disaster at Laipuitlang, Aizawl, Mizoram, India

Lalrokima Chenkual

Disaster Management Centre, Administrative Training Institute, Aizawl 796001, India

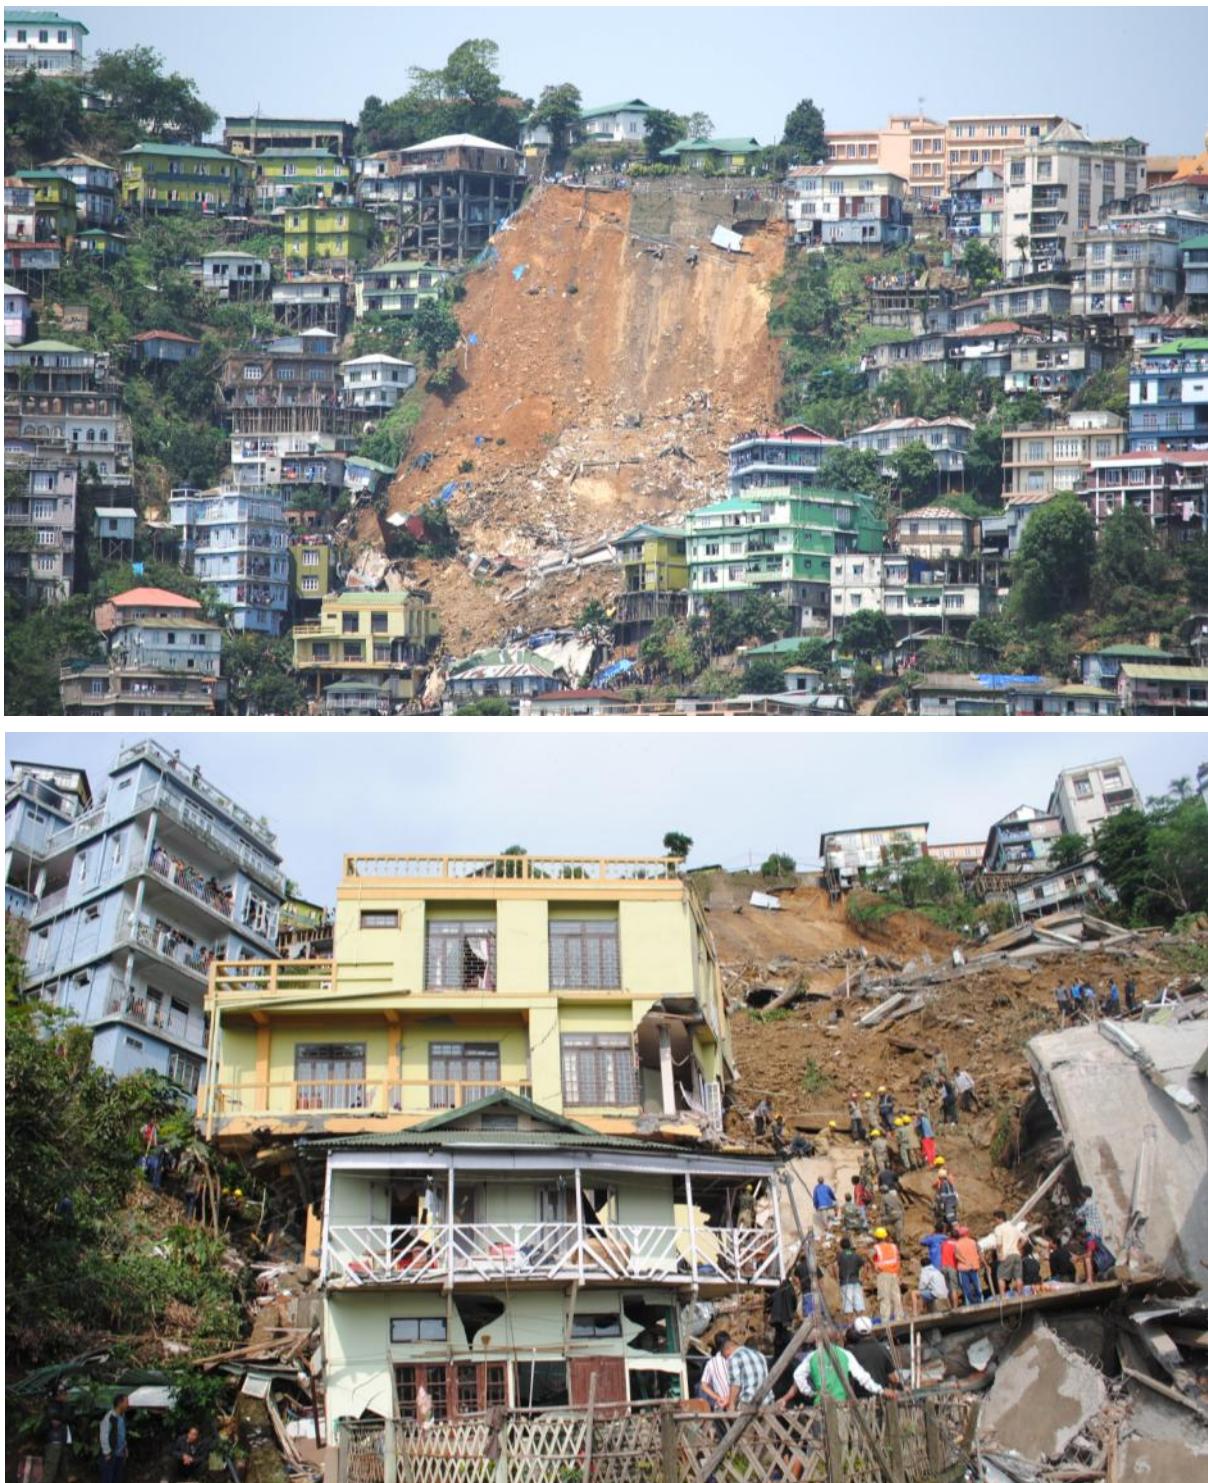
Figure 1. Site and extent of rockslide at Laipuitlang, Aizawl, on 11 May 2013.
