Geological investigation and monitoring of Ramhlun Sports Complex landslide, Aizawl, India

Laldinpuia

Department of Geology, Pachhunga University College, Aizawl 796001, India

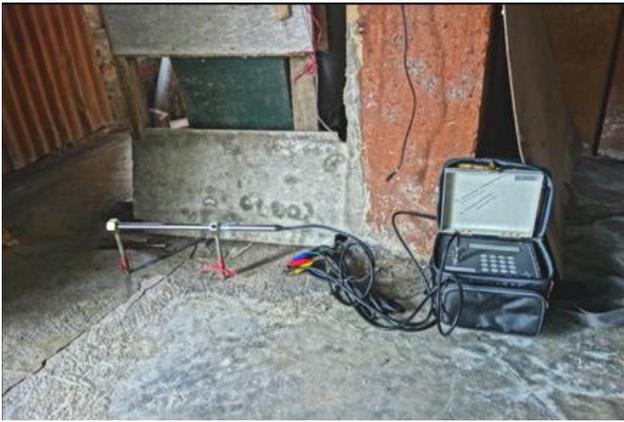
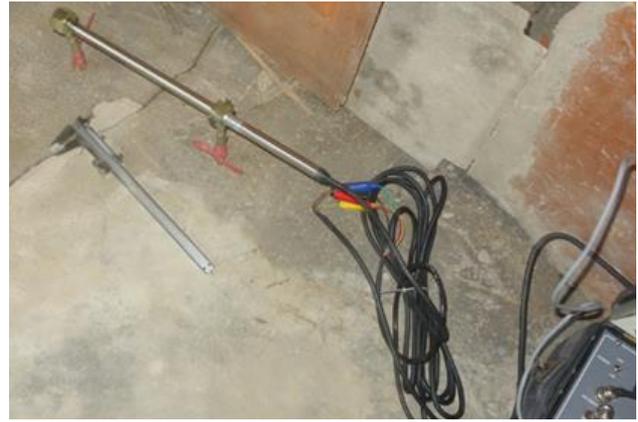
Figure 2 | Displacement of crack using crackmeter instrument (SIS 102 & 101).

3) **Surface deformation monitoring:** The transverse cracks were measured by means of Crackmeters SIS 102 and SIS 100 (**Figure 2**). This will be installed with anchor pins positioned. The rate of movement will be measured by installing tape extensometers SIS 400 (**Figure 3**). The connection will be between landslide area and stable location adjacent to the landslide. This instrument will install for continuous measuring of landslide movement.^{13,16-18} The movement measurement time interval is about 24 hrs (± 30 minutes), i.e. 3:00 P.M.

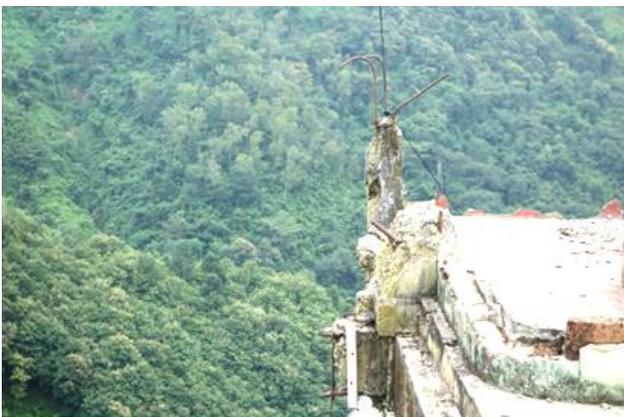
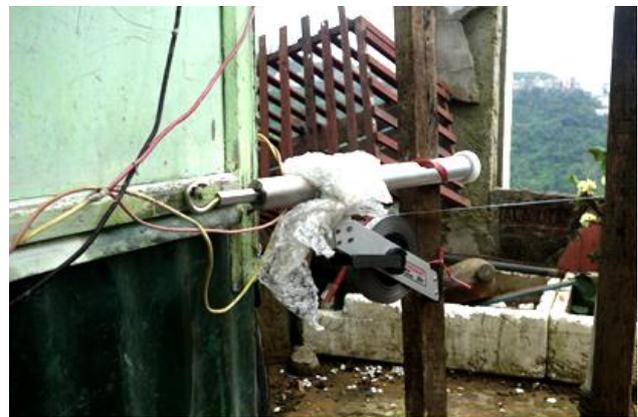
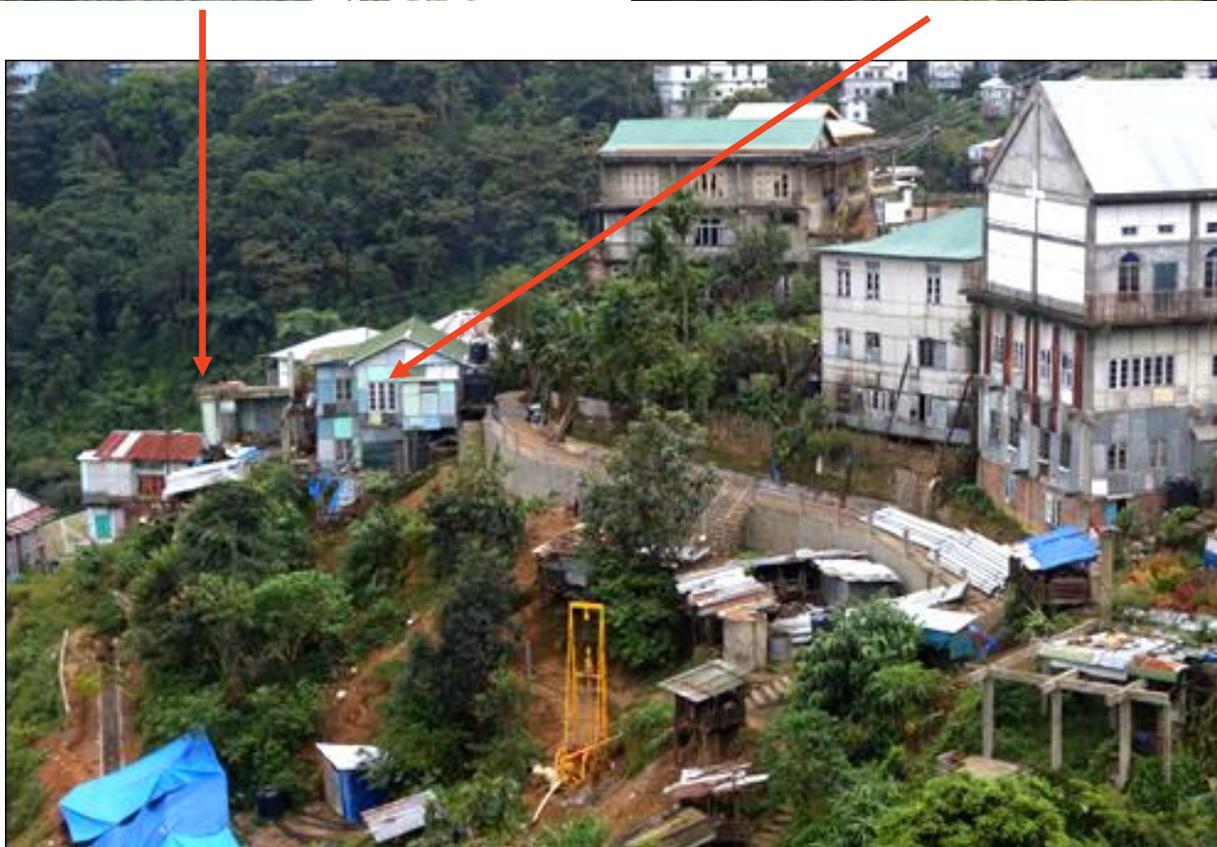
Figure 3 | Monitoring the movement using tape extensometer (SIS 400).

The observed rate of movement was relatively increased when rainfalls increasing (**Table 3**).

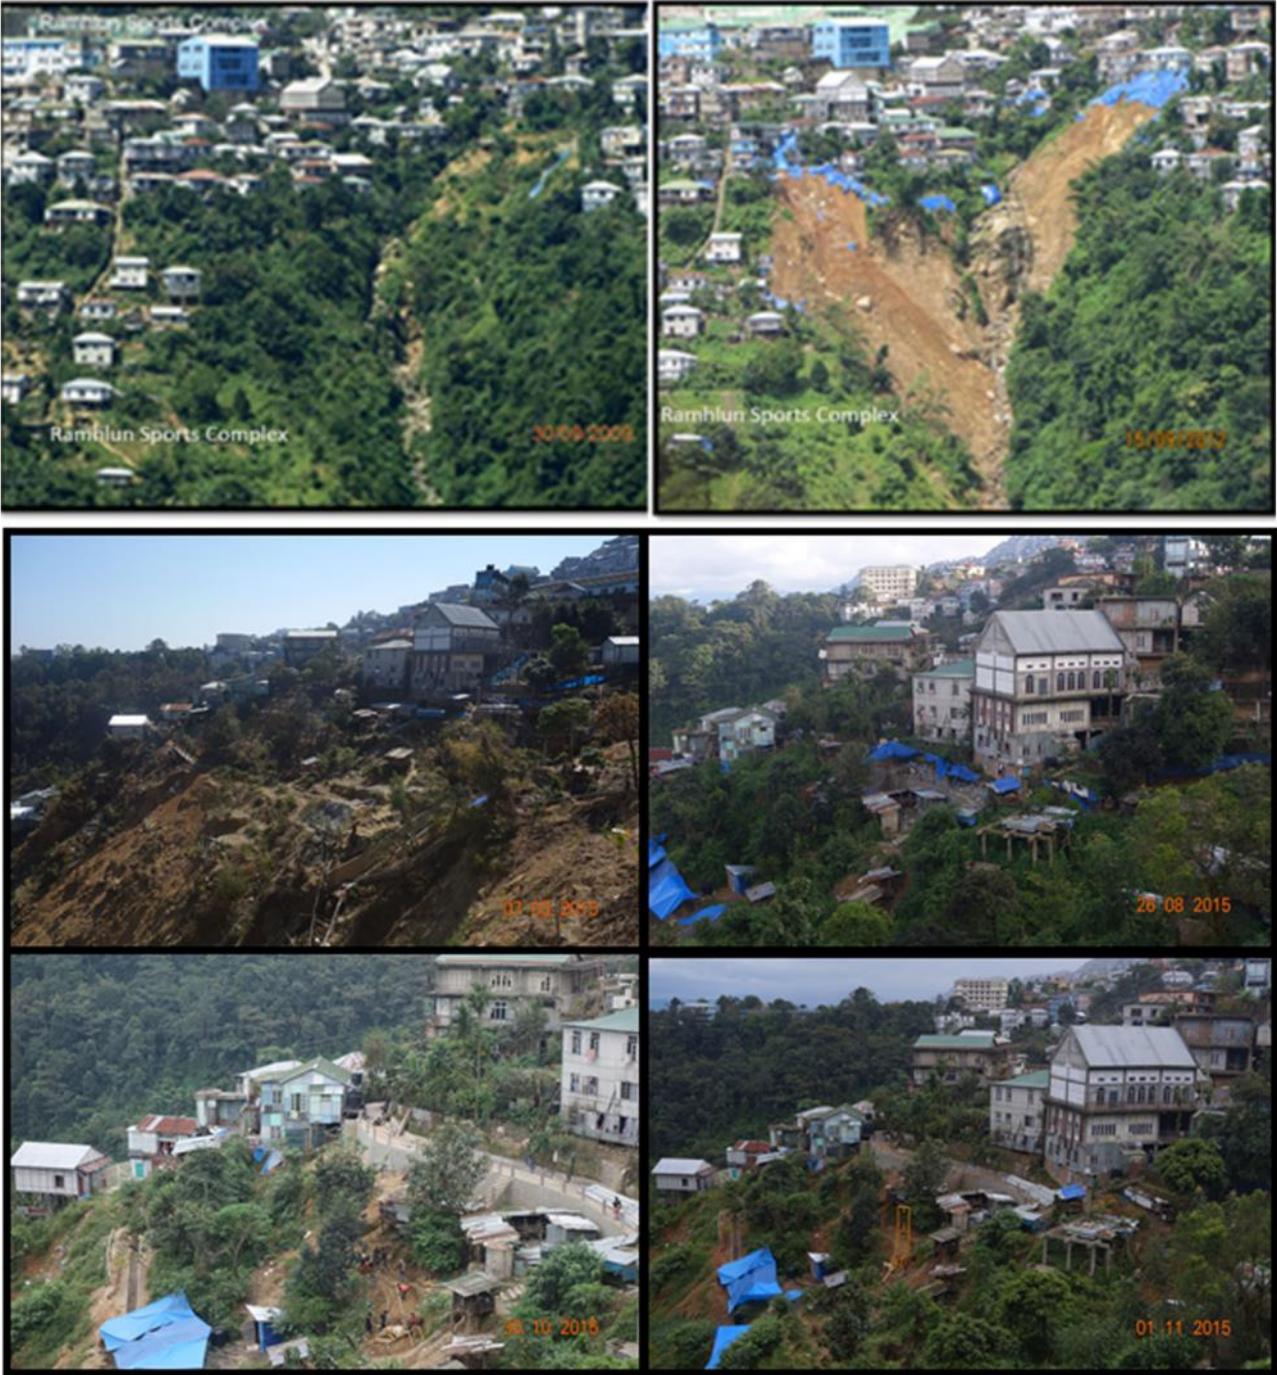
Figure 4 | Photographic monitoring of the study area.

Geologically, the study area belongs to Middle Bhuban Formation, and the main rock types are sandstone, siltstone and thin bed of shale. The general slope amount is 50° due east. Sandstone-siltstone/shale intercalations, jointed vertically exposed along Bangla Lui. A number of cracks developed at the crown portion affecting a number of houses.

The author warns the nearby houses about the possible failure in 2010 after field work along Bangla Lui, studying Ramhlun Vengthar landslide.¹⁹ The photographic investigation was done in this particular area given in the following **Figure 4**.

The geotechnical studies and monitoring of Ramhlun Sports Complex observed that the area is not suitable and unsafe for settlement, construction of road, and not recommended linking road/pavement. The following are suggested:

- ⊕ To construct suitable drainage system above the crown, i.e. along the state PWD road of Market-Ramhlun Sports Complex-Ramhlun Vengthar, and Ramhlun Sports Complex link road.
- ⊕ Settlement and other human activities should be strictly prohibited in the rupture surface.
- ⊕ Planning of link road in the rupture surface should discontinue due to weak nature of soil strength (CBR value <10).
- ⊕ Planting of deep-rooted plants may act as resisting forces.
- ⊕ Deep borehole drilling up to proper bedding, and further detail soil and rock geotechnical studies are suggested.

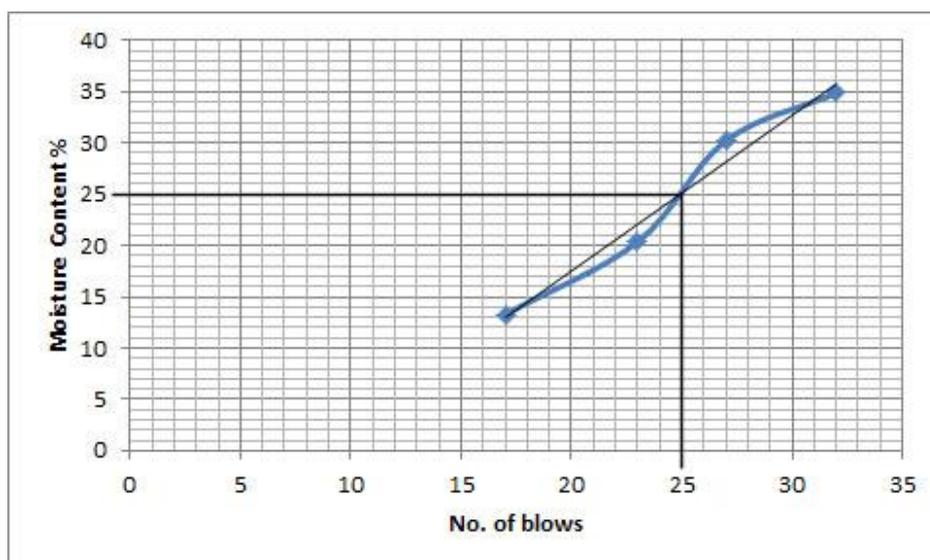
Figure 5 | Liquid limit graph.

The observation values of liquid limit and plastic limit are given in **Table 1**. From **Figure 5**, the liquid limit (LL) value observed is 25, and plastic limit (PL) is 20.4. The plasticity index is 5.4 and is classified as 'slightly plastic'^{22,23} and, can be classed as 'semi-solid' from consistency index, i.e. 1.031.²³
