Conservation of Reiek Tlang: a brief assessment of the adverse effect of vehicles and a plea for its cessation

Andrew Saizama Sailo¹ and C. Lalmuankimi^{2*}

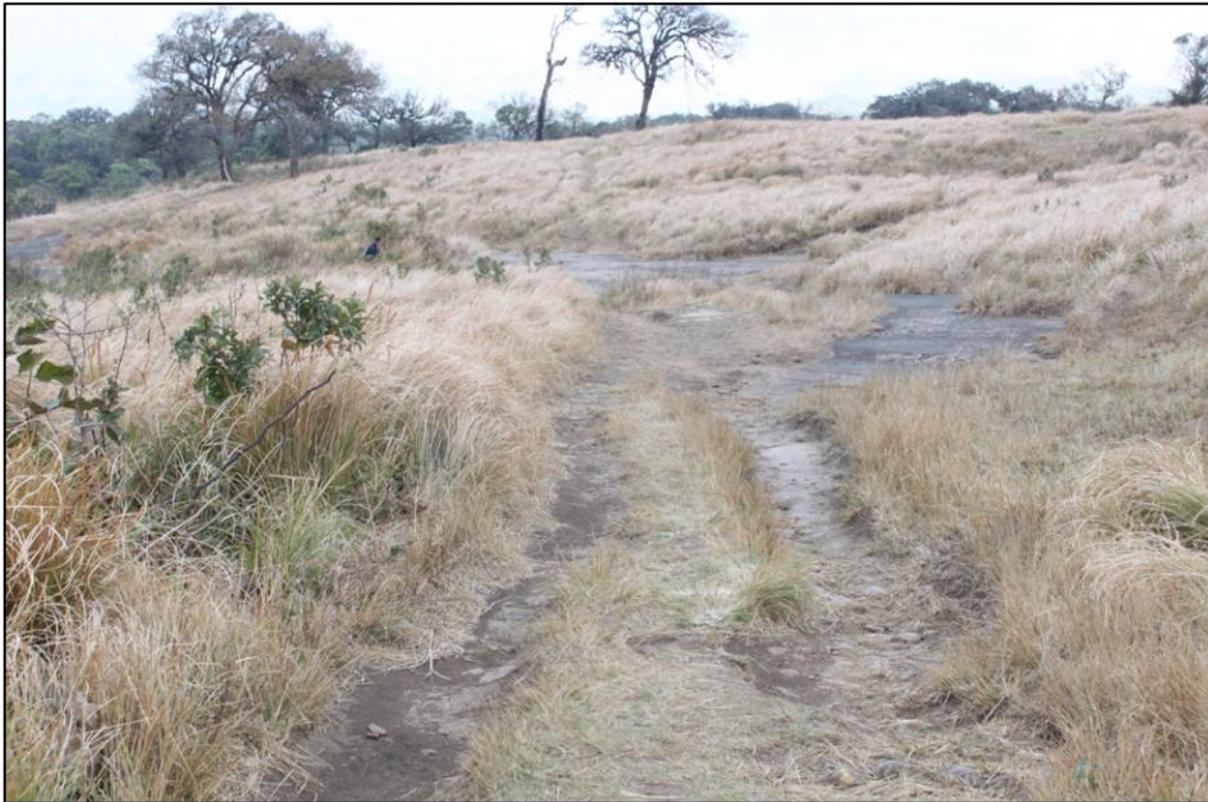
Figure 1. Damage caused by vehicles at Reiek Tlang.

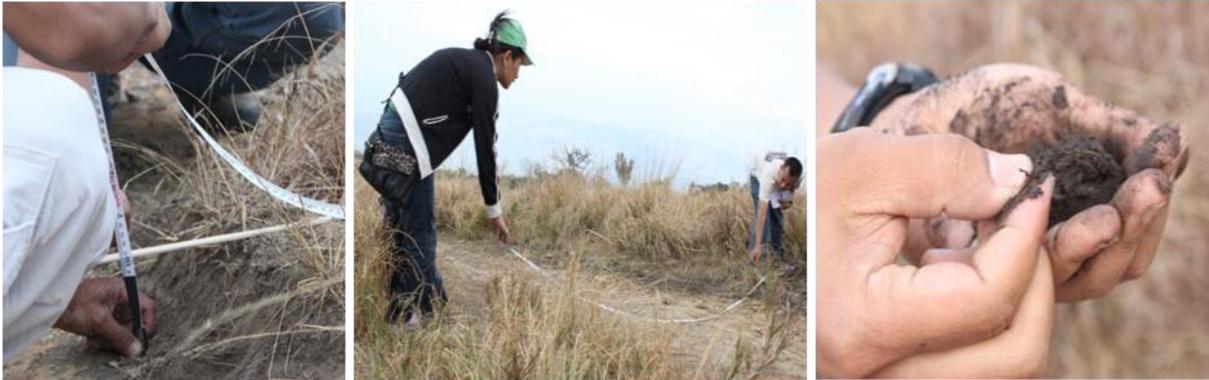
Measurements of soil depth to bedrock in various locations of Reiek Tlang varied from 0 to 25 cm with most falling in the 10cm to 20 cm range. Samples were collected at random locations for subsequent lab tests. Determination that the soils were ‘silt loam’ was made on field. The pH value neared 7, contrast to that typical of soils of Mizoram which often measures beneath 5. While the pH falls within the range of what is considered as favorable for most plants, phosphorous may

Figures 2-4. Measuring depth of soil, width of damage sustained by vehicles and texturing soil.

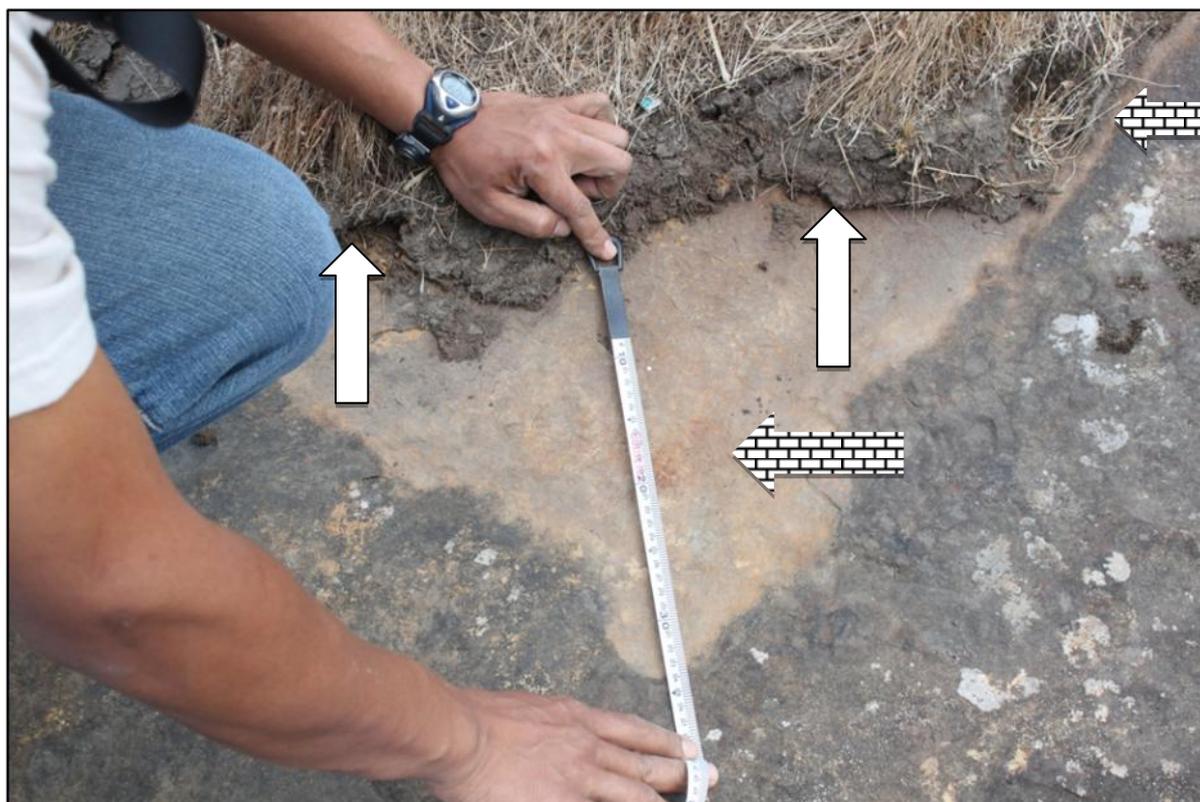
Exposure of bedrock is conducive to further soil degradation. As the velocity of water run-off is higher at the exposed bedrock than in the areas where vegetation exists, it scours the nearby soil. Hence a positive feedback loop accelerates erosion. In fact, examination of such areas where bedrock met the soil did reveal gaps where water runoff had created recesses and inlets priming the soil for collapse.

Figure 6. Checkered arrows indicate areas recently subjected to erosion. The white arrows indicate recesses caused by water run-off, further weakening soil structure.

He went so far as to suggesting ways to restore the bare areas. He recommended that small structures of stones be lined up along

the exposed bedrock, perpendicular to the slope, in order to capture eroded soil. The structures would slow water runoff during rain events and allow deposition, covering adjacent bare areas. Interestingly, the Anasazi people in Mesa Verde did just that to sustain their civilization. Using similar structures called 'check dams', the Anasazi people were able to control erosion for centuries a millennia ago in the barren region of the junction of present day Colorado, New Mexico, Texas and Arizona ('four corners'). Before restoration efforts such as that suggested by local man is considered, vehicular traffic to the top
